BIG BASS LAKE DAM

NDI ID NO. PA-00368  
DER ID NO. 35-126

PHASE I INSPECTION REPORT  
NATIONAL DAM INSPECTION PROGRAM

JULY 1979

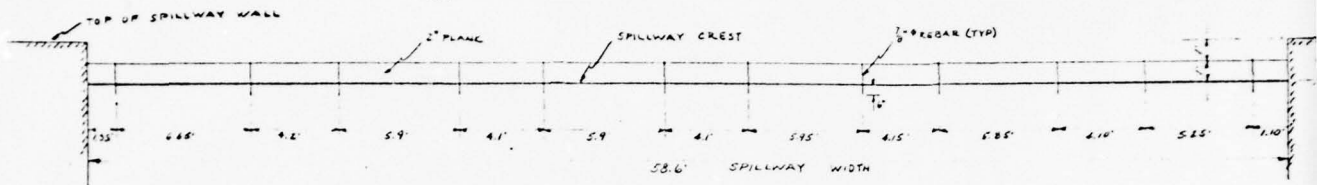
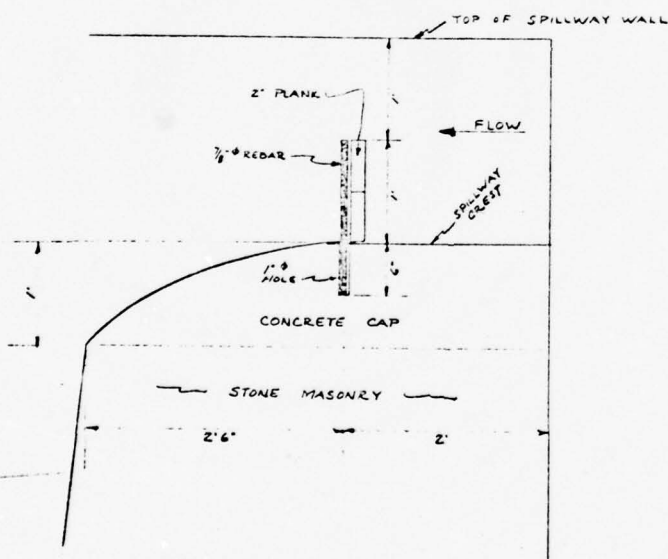
PLATE 4

The design of the flashboards is presented on Plate 4. The design utilized No. 7 reinforcing bars. The designer assumed that the bars would fail at a yield stress of 36,000 psi. Reinforcing bars are not usually supplied with a yield stress of 36,000 psi. Normally, they are supplied at 40,000; 50,000; and 60,000 psi. Furthermore, yield stress is not the usual criteria used in the design of flashboards because, even if yield stress were exceeded, it would only guarantee a slight plastic deformation but not failure. The usual flashboard design uses hollow pipes. Ultimate stress is usually used to ensure failure. For these reasons, the analysis described hereafter for the existing conditions assumes that the flashboards remain intact.

SECTION MOD OF BAR:  $\frac{11.4}{12} = \frac{0.95}{12}$   
 $f' \frac{M}{S} = \frac{20812}{.006} = 37818 \text{ PSI}$   
 $> 36000 \text{ YIELD}$

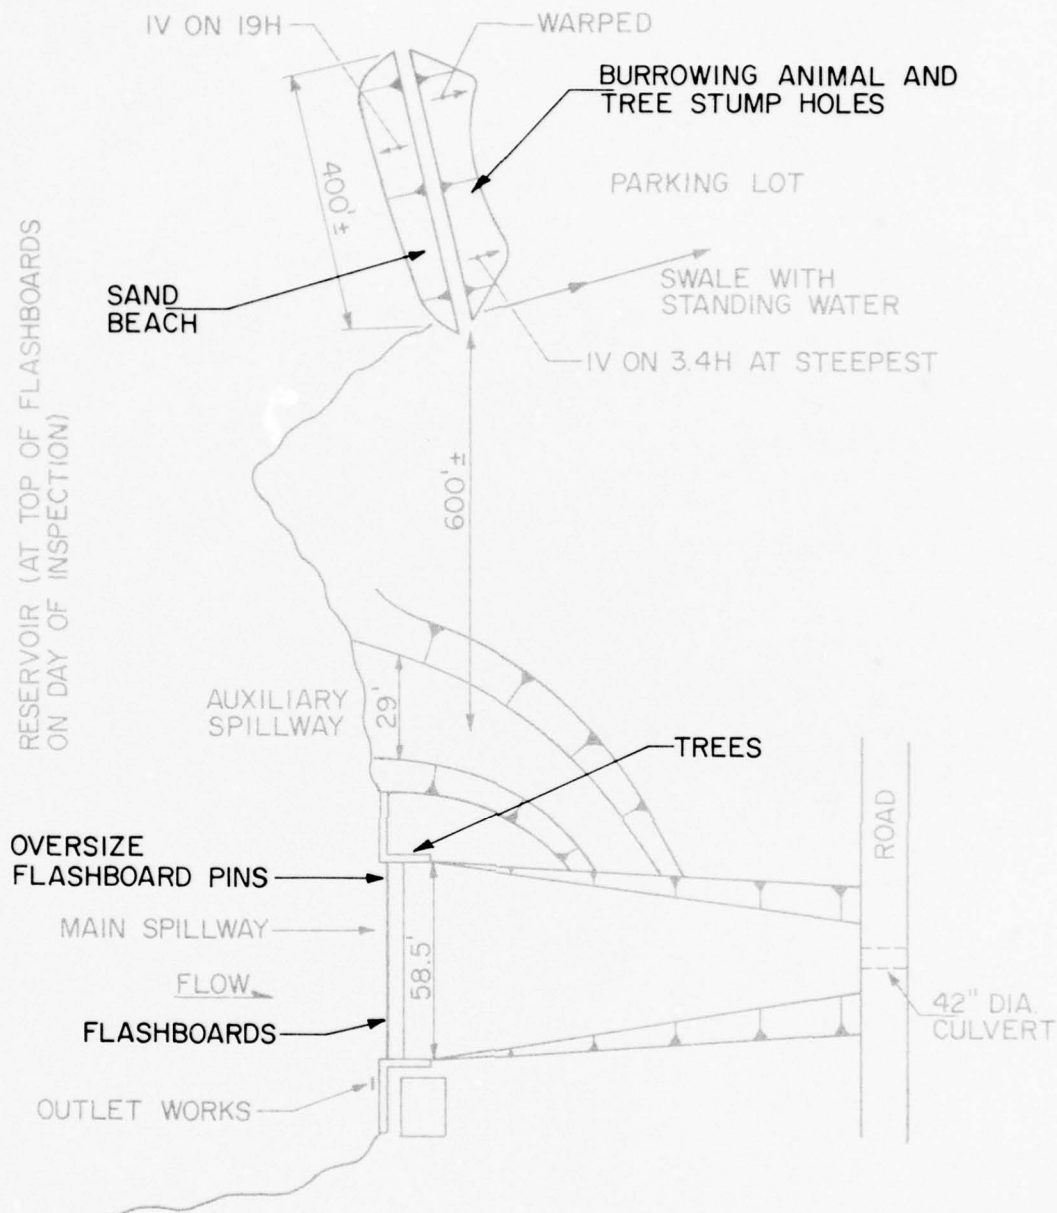
PHASE I INSPECTION REPORT  
NATIONAL DAM INSPECTION PROGRAM  
BIG BASS LAKE DAM  
BIG BASS LAKE, INC.  
RESULTS OF VISUAL INSPECTION  
JULY 1979  
PLATE B-1

a. General. The overall appearance of the dam is good. Some deficiencies were observed as noted below. A sketch of the dam with the location of deficiencies is presented in Appendix B on Plate B-1. Survey information acquired for this report is summarized in Appendix B. On the day of the inspection, the pool was at the top of the flashboards on the main spillway crest.

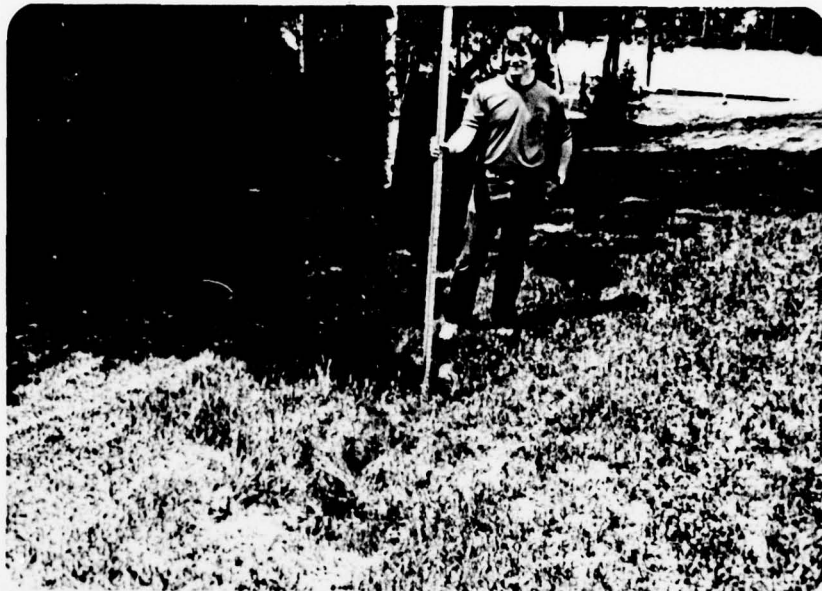
b. Embankment. The embankment is in good condition. The sand beach on the upstream slope is in excellent condition without any evidence of erosion. The grass cover on the remainder of the embankment is in good condition. There are a few holes in the downstream slope. Some holes are caused by decaying tree stumps; others are caused by burrowing animals. None of the burrowing animal holes appeared active. No seepage was observed downstream of the dam. As shown on Plate B-1, a swale was observed extending downstream from the right abutment. The Owner's engineer reported that there used to be a minor amount of seepage in the swale, but that it dried up when the Owner modified the embankment. A few stagnant pools of water were observed in the swale, which does not presently have positive drainage. The drainage in the swale was modified when the area downstream of the embankment was filled to create a parking lot.

C. Burrowing Animal and Stump  
Hole in Embankment

(5) As part of the regular maintenance program, remove trees close to the main spillway weir, fill the burrowing animal and stump holes, and monitor the dry seepage path by the right abutment of the embankment. If seepage is noted, have it evaluated by a professional engineer, as noted above. Also, as part of this program, continue observing the upstream slope of the embankment, especially after floods. If erosion is noted, continue the present practice of effecting repairs immediately.

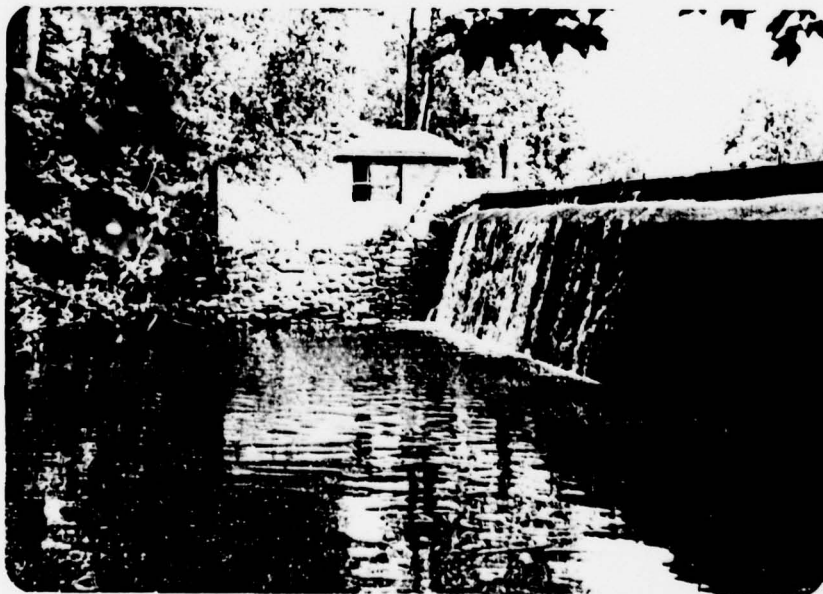
c. Appurtenant Structures. The main spillway is in good condition. No seepage through the masonry was observed; however, a minor amount of flow was occurring over the flashboards, which would have obscured any minor seepage areas. Most of the flashboard pins were No. 7 reinforcing bars. For 20 feet to the right of the left end of the main spillway crest, the flashboards are supported by various pipes and pins measuring from 1 inch to 1-1/4-inches in diameter. The maintenance supervisor reported that these odd size pins had just been put in. He also reported that

The outlet works is in good condition. The sluice gate was opened about 10 percent by one man in about 5 minutes with no apparent problems. The sluice gate is attached to upstream side of the right spillway wall, which is directly exposed to the reservoir.

Susceptible to ice damage.

D. Main Spillway and Outlet Works

(3) Provide protection against ice damage at the outlet works gate.

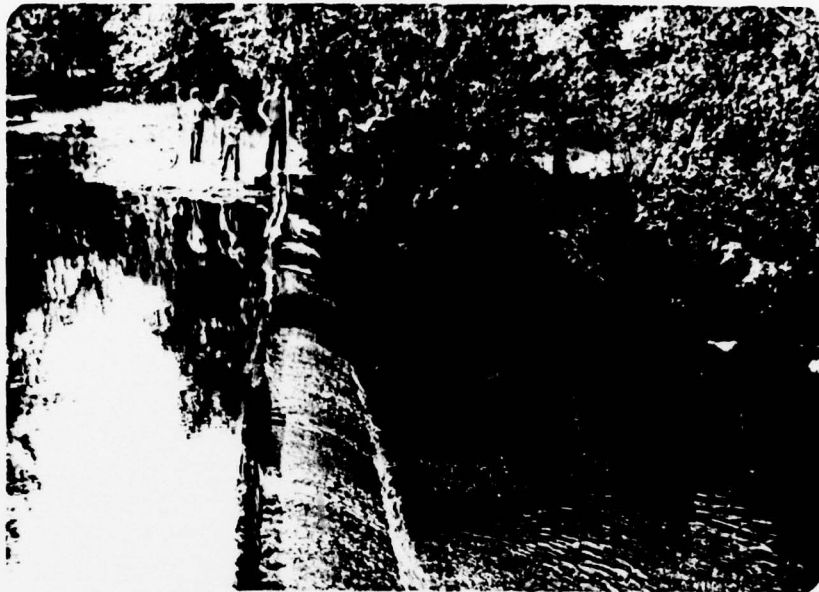
the masonry in the left spillway wall had just been repointed. Small trees are growing immediately adjacent to this area. The survey performed for this inspection revealed that the main spillway crest is 0.5 foot longer than its design length. It also revealed that there is an area at the right abutment of the main spillway which is 0.3 foot below the top of the wall. For low flows; minor constrictions in the channel immediately downstream from the main spillway create a tailwater condition at the toe of the main spillway. At high flows, the constrictions would be drowned and tailwater would be controlled by a 42-inch diameter culvert under a road that is about 150 feet downstream from the main spillway. The top of the road is 2.8 feet below the main spillway crest.

(3) Appurtenant Structures. The small trees growing at the left of the main spillway are a hazard because their roots tend to dislodge the masonry blocks. As this area has just been repointed, the hazard is very minor at present.

E. Main Spillway and Auxiliary  
Spillway Approach Channel
